Manhole Inspection Summary

Manhole # S35Q__008MH

Insp Date: **3/24/09 1:59 PM**

Location Address: **16 W CROSS ST**

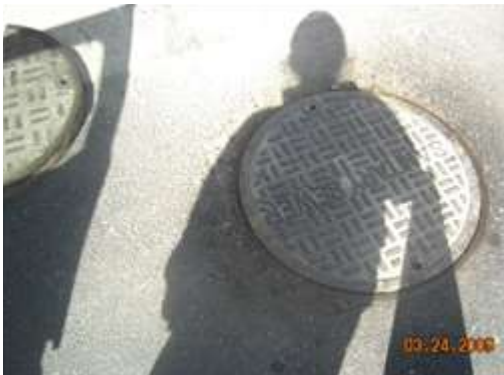
MISC.

Comments **BROKE AND REPLACED COVER TO COMPLETE INSPECTION (see photos)**

REPLACED BROKEN COVER

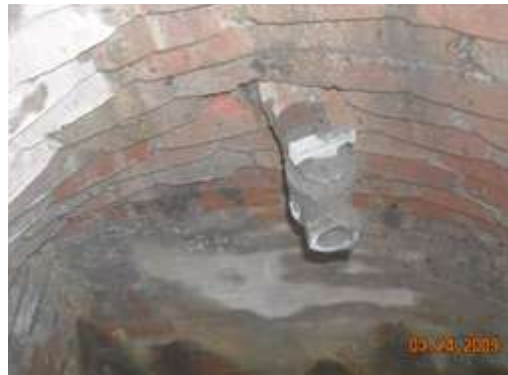
MISC.

PIPE INTRUSION @ 6 OCLOCK
CORBEL WALL

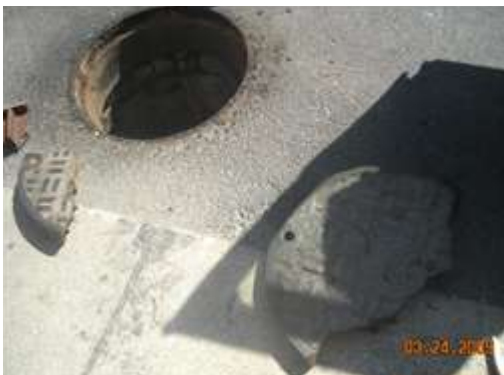
MISC.

BROKE COVER IN OPENNING
ATTEMPT

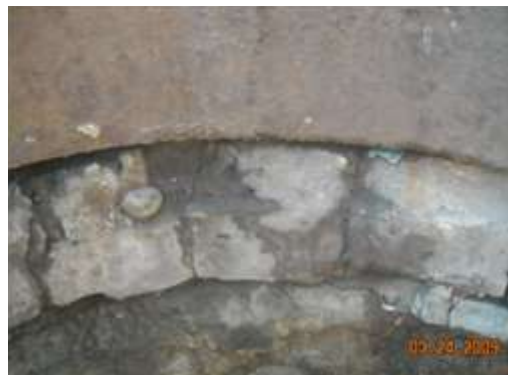
Defect 7

INFILTRATION @ CHIMNEY CRACKS

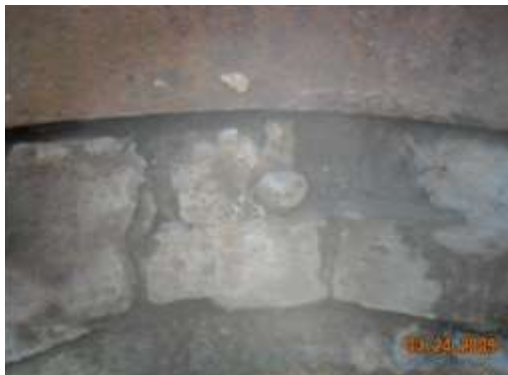
Defect 6

CRACKED CHIMNEY BRICKS

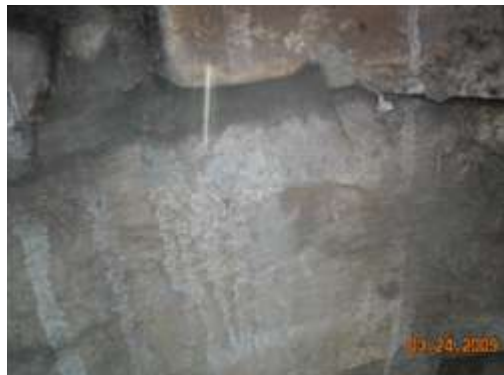
Defect 5

DETERIORATED CORBEL

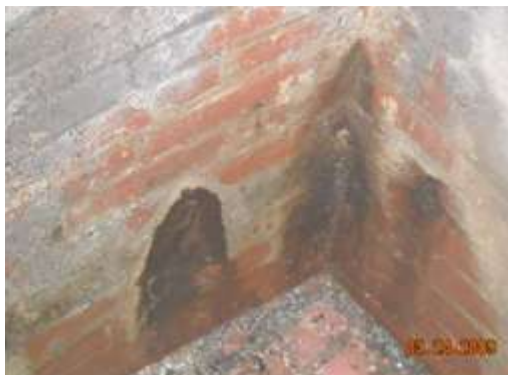
Defect 4

INFILTRATION @ BARREL WALL

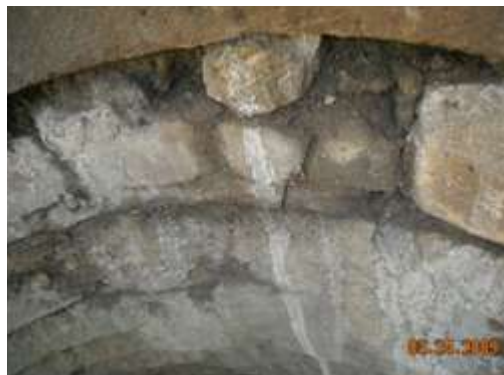
Defect 3

CRACKED CORBEL BRICK,
INFILTRATION IN CRACK

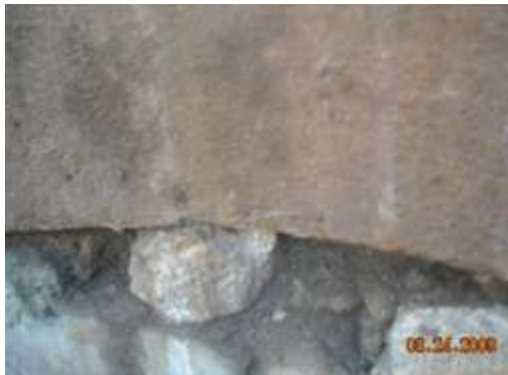
Defect 2

DETERIORATED CHIMNEY

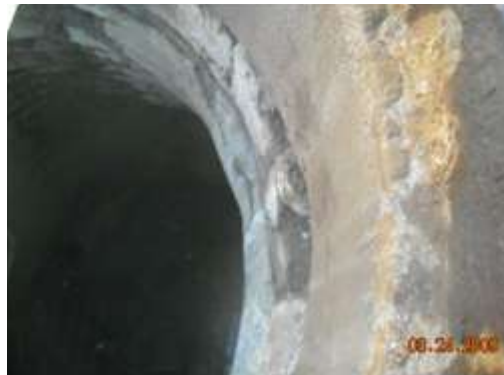
Defect 1

Offset: **1** (in.)

FRAME OFFSET

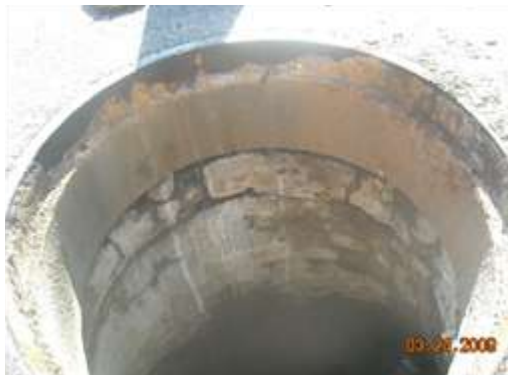
Defect 8

Subject To Ponding: **Sheeting**

INFLOW EVIDENCE FROM SHEETING

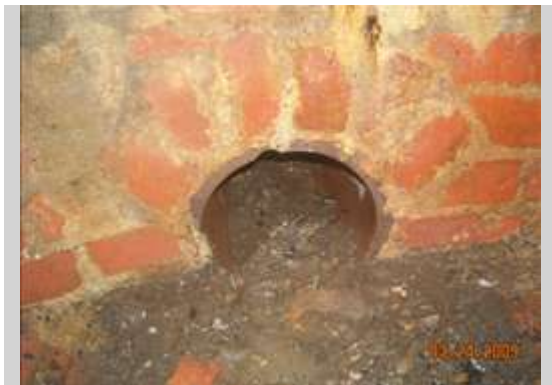
12 O'Clock Outflow

8 in. Circular Gravity Sewer
Pipe Out @ 12 O'Clock

Deposits: ☐ None ☒ **Mud** ☐ Sludge ☐ Debris ☐ Grease

Silt Depth: **1** (in.) Deposits Extent: **Light**
